Room to breathe

Using external insulation can be very effective, but on historic buildings needs to take into account issues such as appearance and a building’s ability to ‘breathe’. Paul Mallion discusses how these were handled on the refurbishment of a Grade II listed farmhouse

Tyland Farmhouse

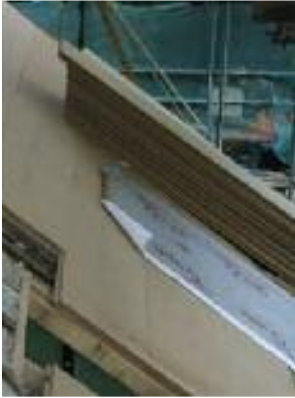
Left: Insulation boards applied over rafters, with wool between, with a Tyvek membrane, counter battens and battens

A similar approach was used on the roof, using a 52mm Steico 'Universal' board placed over the rafters and secured using 100x25mm oak counter battens with stainless-steel hexagon-headed screws. The insulation also provides a degree of racking strength to the roof, but retains the gentle undulations of the structure. The key to successful insulation is elimination of thermal bridges and air leakage, while allowing for movement and shrinkage. In this case, the main junctions were the eaves and between the brickwork and timber frame.

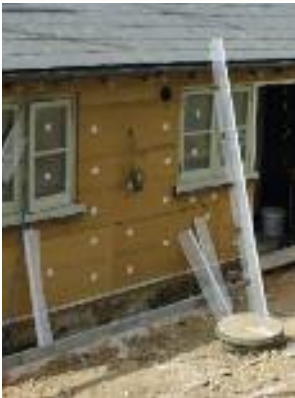
Left below: Woodfibre insulation applied to brickwork, with a first coat of lime render applied to left flank wall

Steico Protect woodfibre was selected for its compatibility with both brickwork and timber frame and its other sustainable properties. For the areas of brickwork, a

stainless steel starter channel was fixed to the wall at DPC level to ensure that the insulation board ran horizontally. Although the channel does act as a thermal bridge to some degree, it protects the exposed bottom face of the insulation and supports the render drip bead.

The brickwork required a thin levelling coat of lime render to form a flat surface for the fixing of the boards, as gaps behind the insulation dramatically reduce the effective U-value through 'thermal bypass'. Insulation boards were tongued and grooved for good fit and laid in stretcher bond. Five thermally broken Ejot nylon anchors were used per board. The stainless steel pin is driven deep into the anchor, leaving a hollow head which is plugged with insulation to reduce the thermal bridge.
